Re: 2019 South End Study

The Pickerel Lake Conservancy and South End Association hired Clark Engineering to evaluate and provide possible solutions to improve water quality in the south end of Pickerel Lake in the area of Webster Boulevard.

The focus areas of this study are the local roads along Webster Boulevard and the area upstream of the CR6 culvert. An on-site review of the roads was performed in August of 2019. The study included a review of USGS Streamstats to determine the size of the watershed upstream of CR6 culvert. A literature review of gravel road maintenance techniques and ice block drainages was also performed.

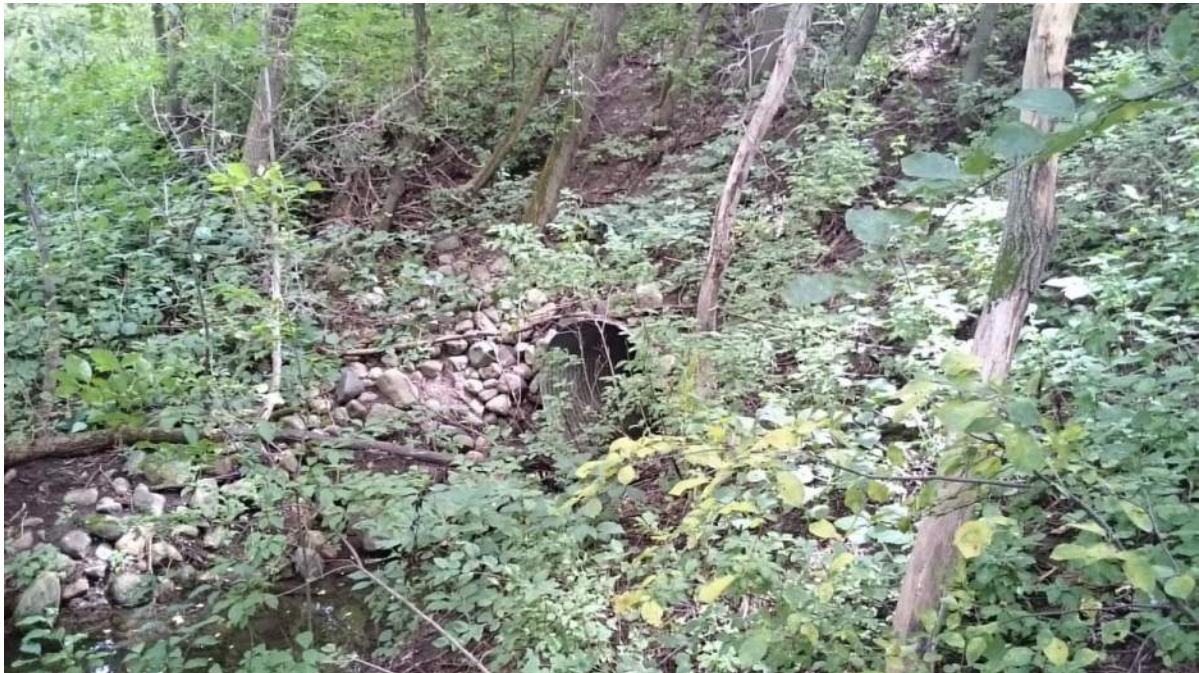
To improve the efficiency of steaming CR6 culvert, selective removal of vegetation downstream will provide the steamer operator easier access to the culvert. Removing the vegetation will allow sunlight to passively thaw the culvert. Photograph 1 illustrates how the outlet is shaded by vegetation, accumulated debris, and the undefined channel. The caution with vegetation management is to avoid clear cutting. The vegetation on the slope stabilizes the hillside. Vegetation management should focus on the area downstream of the culvert. The first stage of vegetation management is to remove the dead and dying trees. The small trees without bark in Photograph 1 should be removed immediately.

Photograph 1 is facing south looking at the outlet culvert.

The US Army Cold Region Research & Engineering Laboratory identifies steam as a method to melt ice in culverts. The recommendation is to use a steamer to thaw out the culvert every spring. Day County Highway Department has a steamer available. The South End Association has been in contact with the County to use the steamer to clean out the CR6 culvert. Removing ice from CR6 culvert is part of the solution for managing spring runoff. Keeping the smaller downstream culverts open will also play an important role in managing water flow.

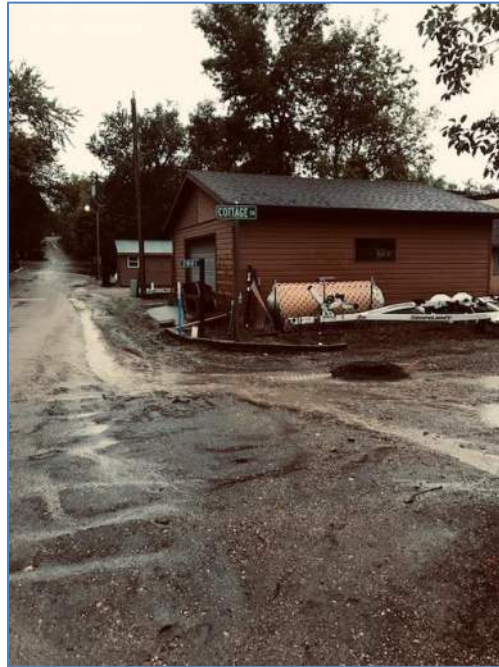
**Segment two** is from Scenic Avenue to Cottage Street. The intersection of Scenic Avenue is a flat area. East of the Scenic Avenue intersection there are two retaining walls on both the north and south side of the road. The purpose of these retaining walls is to prevent water from entering the private property. East of the intersection is a downhill slope that flattens out at Cottage Drive. There are underground utility conflicts on both sides of the road. Photograph 2 illustrates water in the secondary ditch in the road and the existing inlet to the culvert at Cottage Drive. Photograph 3 demonstrates where the secondary ditch is improperly conveying water to the culvert. Photograph 4 is upstream of the culvert at Cottage Drive. From this angle, the lack of a ditch is forcing water on to the road.

**Photograph 2 is facing west at the intersection of Webster Boulevard and Cottage Drive. This is an example where a secondary ditch needs modification. (Dan Pearson - 2019)**

- Maintenance work:
  - Install SD DOT specified gravel surface.
  - Shape road – ditch cleaning to maintain drainage.
  - Remove secondary ditches/ditch construction.
  - Clean out the culvert at Webster Boulevard.
- Intermediate work:
  - Replace existing culvert.
  - Install manholes with inlet grates on the south and north side of Webster Boulevard (see plan sheet 3). A second option is to install a manhole system that collects sediment. The figure below is an example of a commercial system that is available.
  - Install valley gutter on the south side of Webster Boulevard at Scenic Avenue.

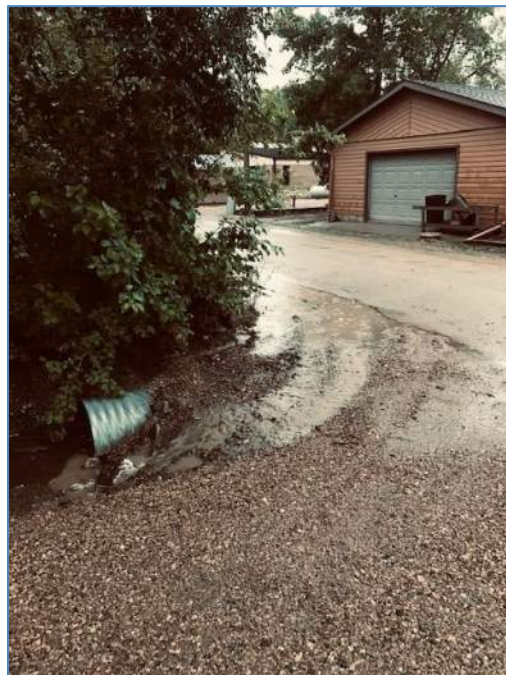
**Photograph 3 is looking at the culvert in the southwest corner of the intersection of Webster Boulevard and Cottage Drive. The water from the west is not correctly entering the culvert. Work at this location consists of re-establishing the ditch from the west. (Dan Pearson -2019).**

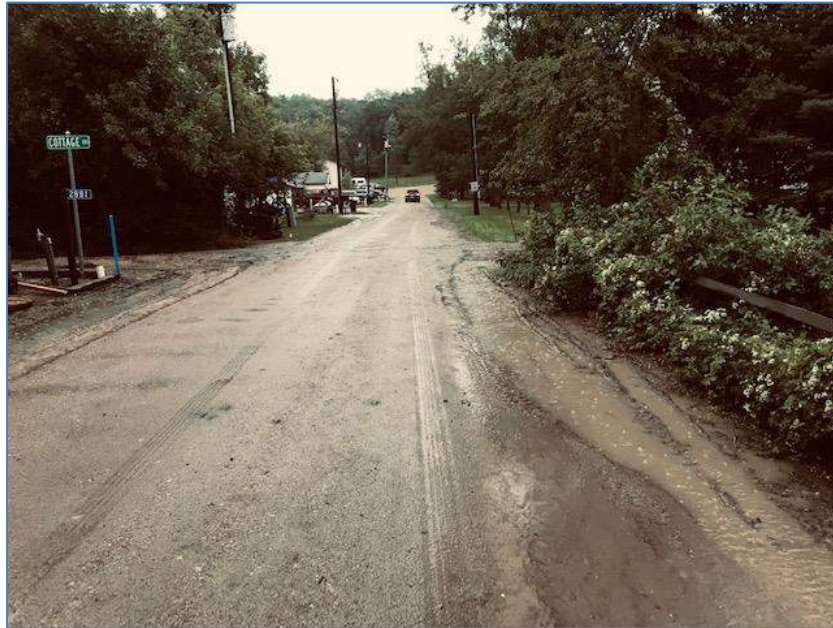
**Photograph 4 is facing east at the intersection of Cottage Drive and Webster Boulevard. This is where the ditches are not functioning correctly (Dan Pearson -2019).**

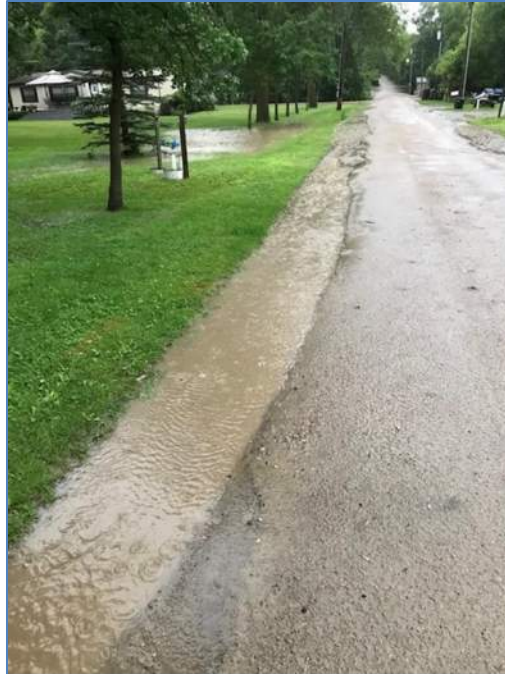
**Segment three** is from Cottage Drive to Huggett Lane. This segment is the flattest and lowest portion of Webster Boulevard. The water flows east to west into the culverts under Webster Boulevard at the intersection of Cottage Drive. Underground utility conflicts are high in this area primarily along the north side of Webster Boulevard. There is a high density of cabins on the north side of the road with access points/driveways. On the south side of Webster Boulevard, the ditch should be reestablished. Photograph 5 shows the standing water in the secondary ditch along the road and water in the ditch location.

**Photograph 5 is facing west on Webster Boulevard from near the intersection of Huggett Lane. Water can be seen in the secondary ditch. This is the area where the maintenance needs to be complete to remove the secondary ditch and re-establish the ditch. (Dan Pearson -2019).**

- Maintenance:
  - Install SD DOT specified gravel surface
  - Shape road – ditch cleaning to maintain drainage.
  - Remove secondary ditches/ditch construction.
  - Clean culvert.
  - Re-establish south ditch.
- Intermediate work:
  - Replace existing culvert under Webster Boulevard.
  - Install manhole with inlet grate in the northwest corner of Webster Boulevard and Cottage Drive.
  - Expand the width of the south ditch to increase capacity.

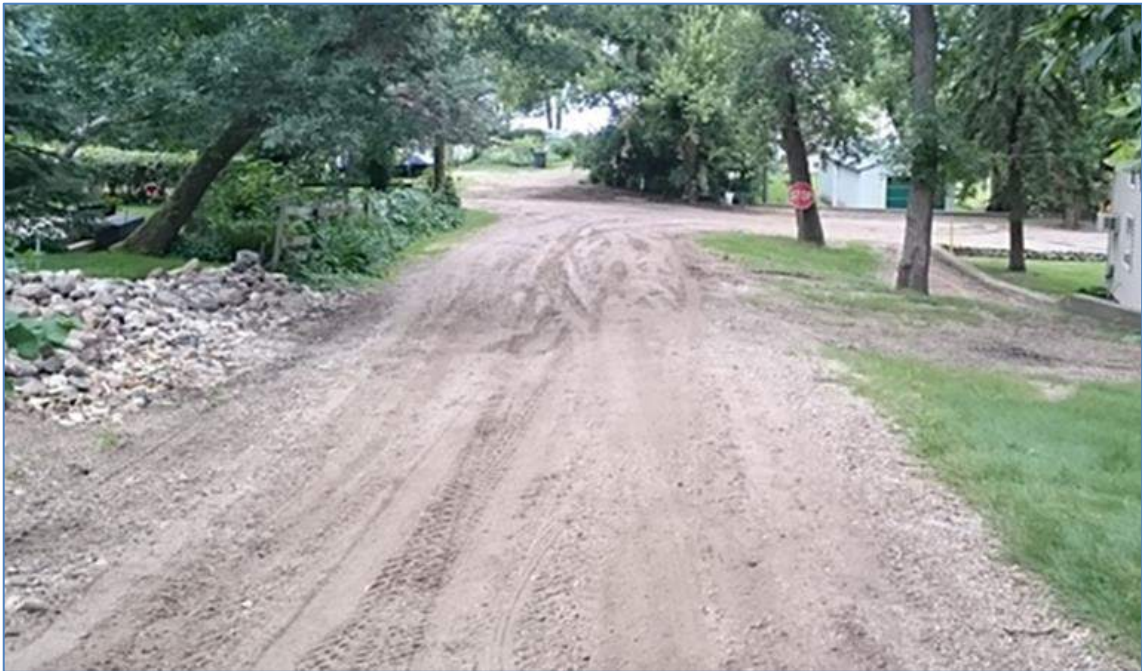
The township road segment's high point is at CR6. The road right of way is the standard township road width of 66 feet. The road is in the west half of the right of way. Photograph 6 illustrates the poor condition of the road surface. The retaining wall that directs flow to Webster Boulevard can be seen in photograph 7. Photograph 8 identifies a potential location of a raingarden that could provide stormwater manage along Scenic Avenue. The work areas are shown on sheets 7 and 8.

**Photograph 6 is facing north on Scenic Avenue. (P. Clinton - 2019)**

- Maintenance:
  - Install SD DOT specified gravel surface.
  - Reshape the road includes blade maintenance and ditch cleaning.
  - Remove secondary ditch.
- Intermediate work:
  - Improve the east ditch by blading from CR6 to Webster Boulevard.
  - The west ditch, approximately 250 feet north of CR6 install a wing ditch with check dams to keep water off the adjacent property.
  - North of Webster Boulevard install a permeable grass pavement system to the lake. Figure 3 is a brochure that summarizes a grass pavement system.
  - Install raingarden.
  - Place culverts at the existing access points.

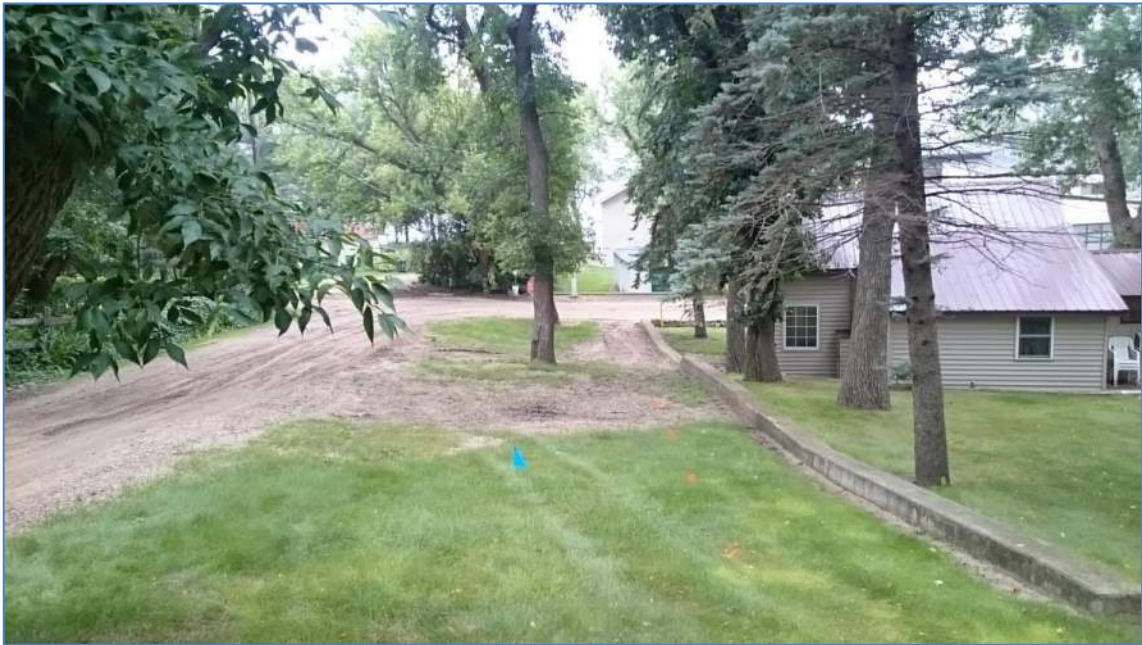
**Photograph 7 is facing north on Scenic Avenue. (P. Clinton - 2019)**

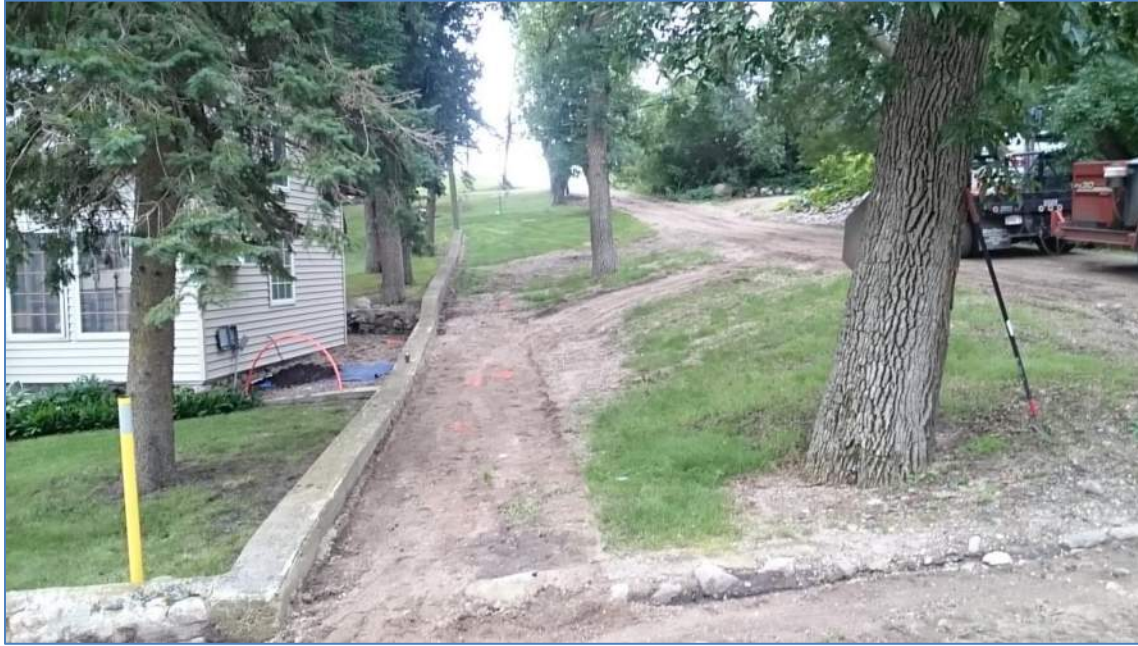
**Photograph 8 is facing south from the intersection of Scenic Avenue and Webster Boulevard.**

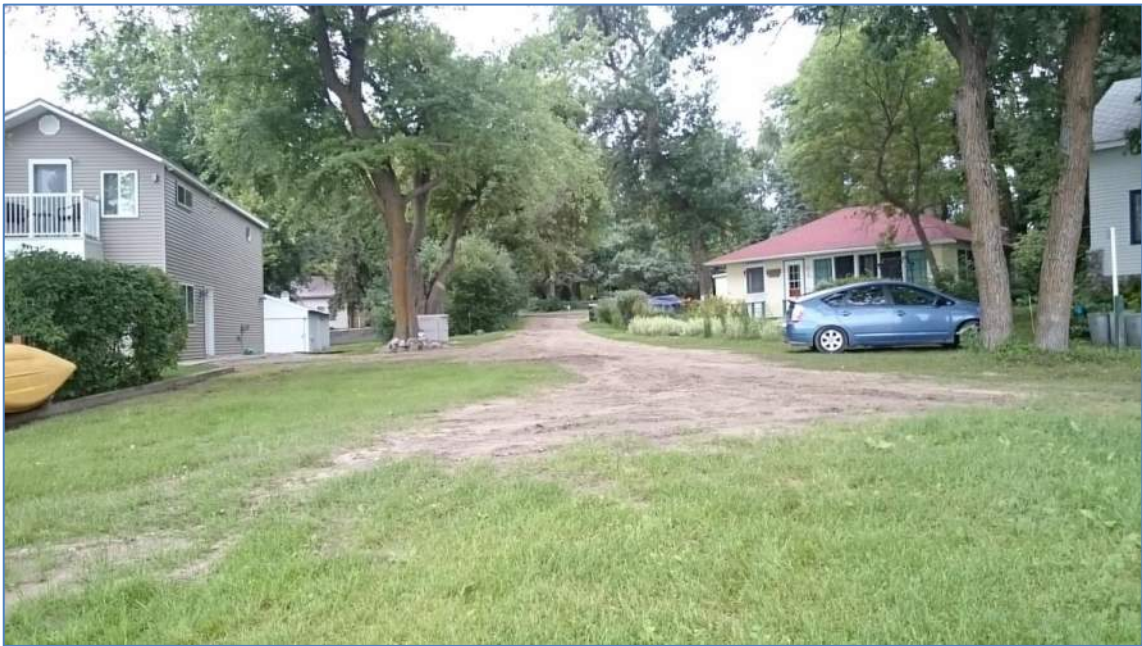
The second segment of Scenic Avenue is from Webster Boulevard to the lake. The alignment of the existing roadway north of Webster Boulevard is off-center to the west. The east side of the existing road is approximately 4 to 6 feet above the adjacent property. Photograph 9 illustrates the sediment deposits from rain events. Photograph 10 demonstrates the flow of water in a secondary ditch. In the background, of the photograph overland flows of water can be seen going to the lake. This is a good location for a grass pavement system that will provide a stable surface for vehicles and infiltrate water into the subgrade. Plan sheet 7 identifies the location and has a cross section of the system.

**Photograph 9 is looking south at Scenic Avenue from the lake shore.**

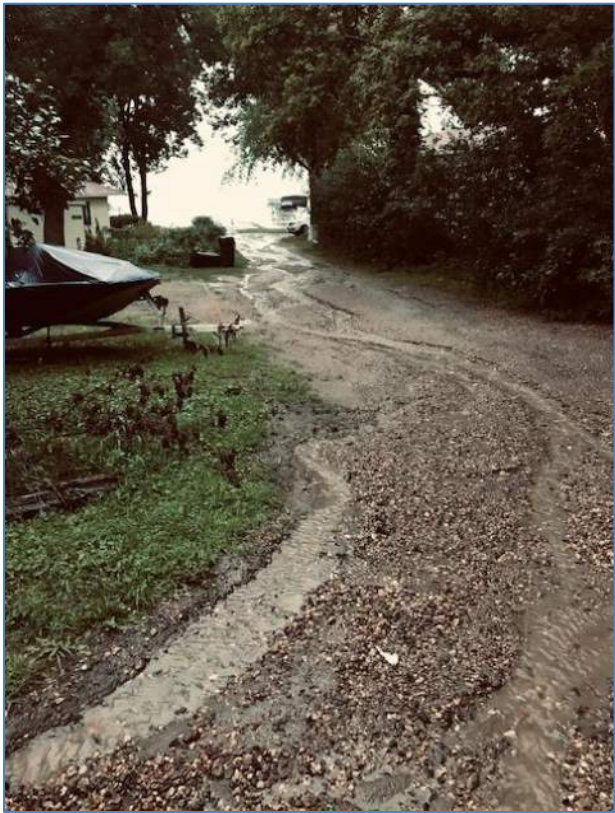
**Photograph 10 is looking north down Scenic Avenue and Webster Boulevard. This is a proposed location for a permeable grass pavement system (Dan Person 2019).**

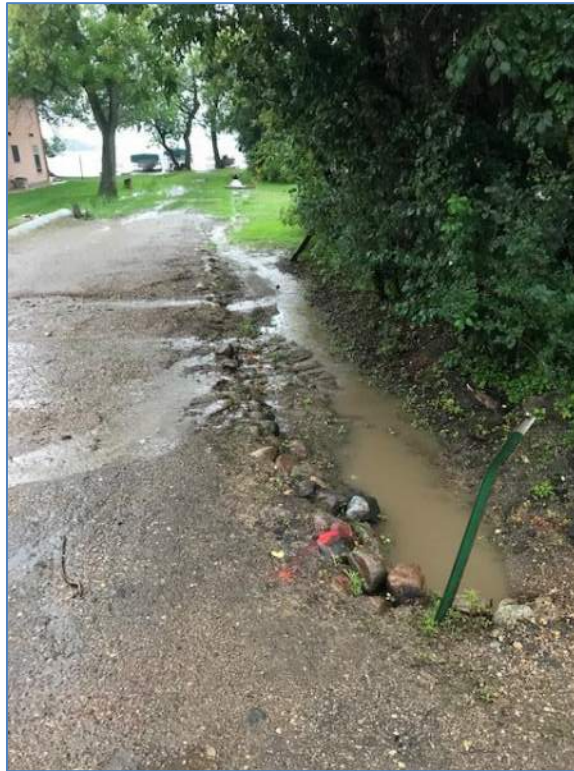
Webster Boulevard divides Cottage Drive into two segments. The southern segment is 300-feet-long by 33-feet wide south of Webster Boulevard. The road surface is recycled crushed concrete. The channel adjacent to Cottage Drive starts at the CR6 culvert. This segment of the channel that meanders through a wooded area to culverts located at the sanitary lift station. The west channel is a trapezoidal ditch with variable width and approximately 2 ½ feet deep. On the east channel is an undefined ditch filled with sediment.

**Photograph 11 is looking north down Cottage Drive from Webster Boulevard. This photograph is an example of ditch re-establishment and improving the surface using a grass pavement system (Dan Pearson - 2019).**

- Remove debris and manage vegetation in the meandering channel.
  - Intermediate work:
    - Design and sizing of the west ditch improvements starting at the culverts near the lift station. Reconstruct the channel with a consistent width and retaining wall system to stabilize the banks. This improvement would reduce the erosive soils and gravel entering the channel and being deposited downstream at the Webster Boulevard culvert.

- The west ditch improvements starting at Webster Boulevard going north consist of resizing and replacing the culvert and reconstructing the ditch to the lake.

- Re-establish the east ditch beginning at the private driveway going north to Webster Boulevard.
    - Clean out the existing ditch from Webster Boulevard to the lake.

- Cottage Drive surface improvements from Webster Boulevard to the lake is to install a permeable grass pave/ring system. This system consists of plastic ring structure that will provide drainage and support vehicles.

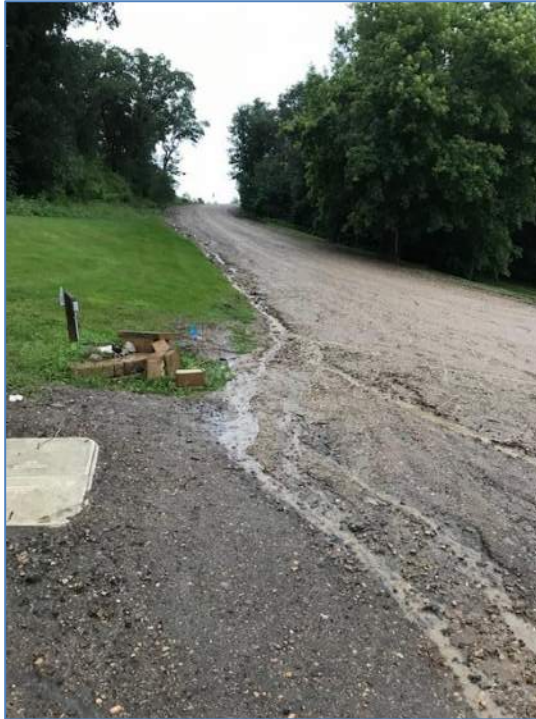
Huggett is a private road that begins at CR6. The high point of Huggett Lane is at CR6. The road surface consists of pit-run fine gravel that is highly erodible. Secondary ditches are forming in the road which prevents water from flowing into the ditches or buffer area adjacent to the road. North of CR6 on the east side of the road is a drainage swale that wraps around the lodge at a higher elevation and terminates in a detention area just north of the lodge building. The detention area has a drain that discharges into the lake east of the boat refueling area. Work areas are shown on sheets 11 and 12.

**Photograph 12 is looking uphill at Huggett Lane from the intersection of Webster Boulevard. This is an example of where the secondary ditches in the road need to be repaired (Dan Pearson - 2019).**

- **Propose improvement**
  - Maintenance:
    - Resurface the road with SD DOT specified gravel surface.
    - Ditch cleaning.
    - Install wing ditches to remove secondary ditches.
  - Intermediate work:
    - In the southeast corner of Short Street and Webster Boulevard create a rain garden system.
    - Create a pervious parking area with a subsurface collection system in the parking area south of the docks and beach area.
    - Create a grass pave/ring buffer along the shoreline of the lake. The grass pave/ring is a permeable paving system that can be driven on.

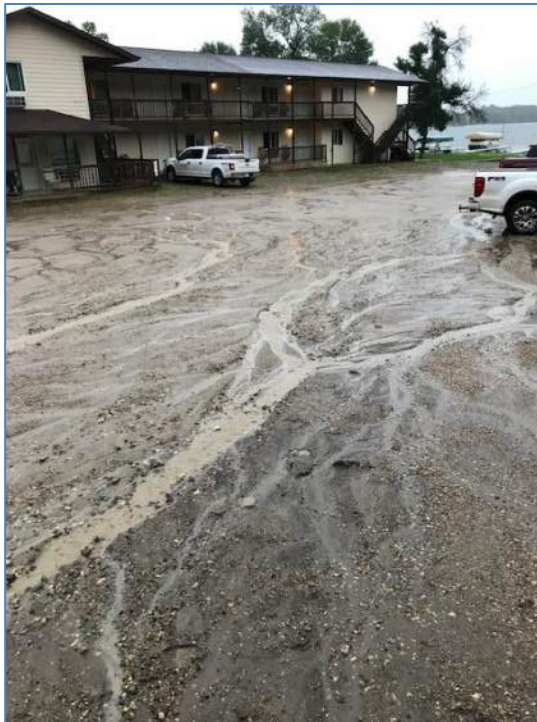
**Photograph 13 is facing north from the intersection of Webster Boulevard and Huggett Lane. This is an example of where a permeable parking system would allow water to soak into the ground and runoff at a lower rate (Dan Pearson - 2019).**

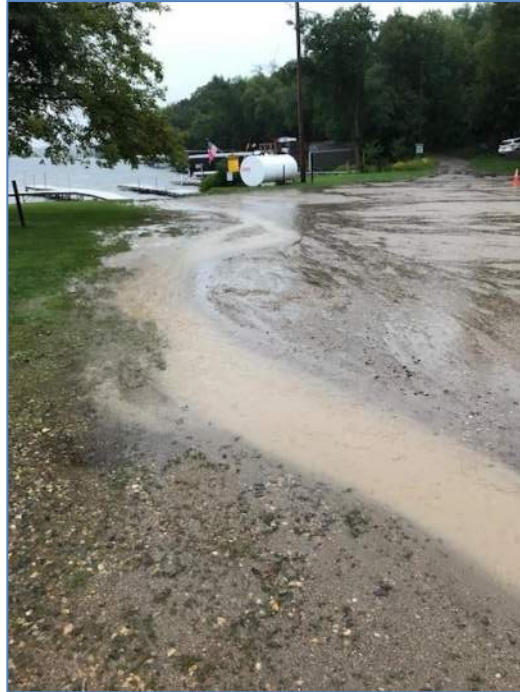
**Photograph 14 is facing northeast from the west building of the lodge. In the background of the photograph near the dock is the proposed location of the grass pavement system. This system will filter the surface water through the grass and allow water to soak into a course rock subgrade (Dan Pearson - 2019).**
