**PICKEREL LAKE
DAY COUNTY,
SOUTH DAKOTA**

**AQUATIC PLANT SURVEY
2023**

Pickerel Lake Aquatic Plant Survey
Prepared for The Pickerel Lake Conservancy
2023

PICKEREL LAKE AQUATIC PLANT SURVEY

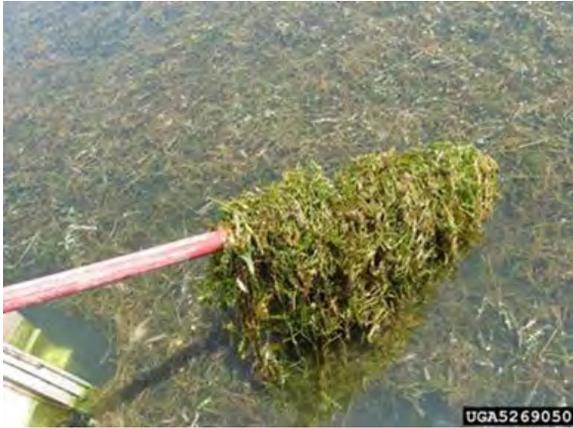
Fig. 2. Example of nuisance level surface matting of curlyleaf pondweed on a boat paddle. Photo credit USGS.

Pickerel Lake is known to have curlyleaf pondweed since at least 2019, an invasive plant species that exhibits these characteristics. While curlyleaf pondweed is actively growing it becomes a detriment to lake users when it mats at the surface of the lake and interferes with recreation (Fig. 2).

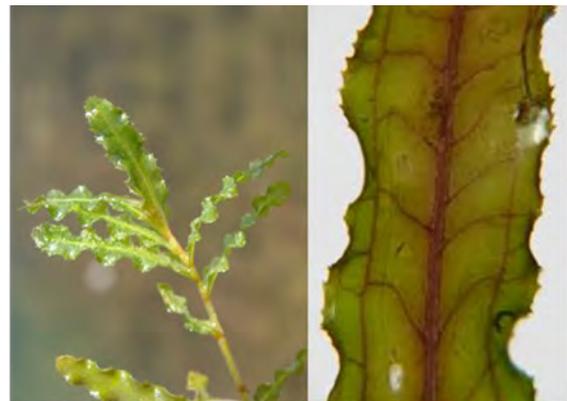
Fig. 3. Curlyleaf pondweed form. Left Shows the characteristic lasagna noodle appearance with round tips while right shows a close up of the toothed leaf margin.

Curlyleaf pondweed is easy to identify when mature, having a “lasagna noodle” like leaf appearance (Fig. 3). It is South Dakota’s only pondweed with curly leaves

that has serrated, or toothed, leaf margins and a rounded, rather than pointed, tip. It may be difficult to identify when immature because it does not have the characteristic curling and can be mistaken for other similar looking plants.

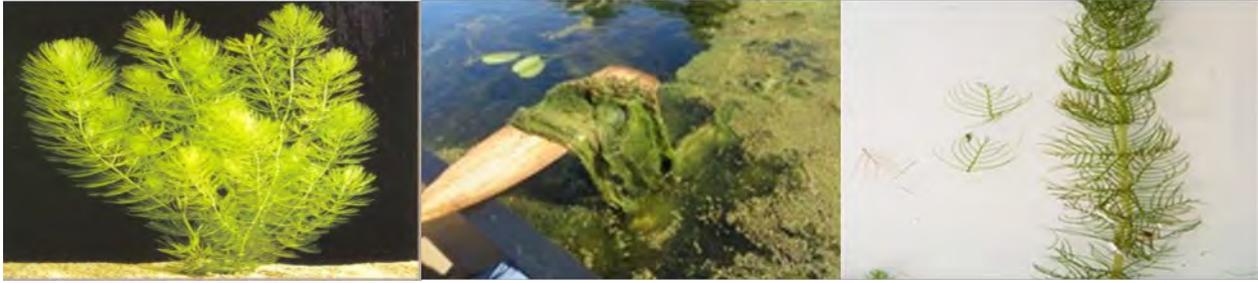
Coontail Filamentous Algae Northern Watermilfoil

Fig. 13. Most commonly sampled vegetation on Pickrel Lake for combined surveys were coontail, filamentous algae, and northern watermilfoil. Filamentous algae is an “algae”, while coontail and northern watermilfoil are true plants.

Five species dominated the plant community, accounting for 85% of all biomass collected. Those vegetation types included coontail, filamentous algae, northern watermilfoil, muskgrass, and water stargrass (Fig. 13).
